U.S. Department of
Homeland Security
**United States
Coast Guard
Auxiliary**

Auxiliary Aircraft Facility Maintenance Standards

The Case For A Fresh Approach

RP Group Proposal
AUG 01 2014

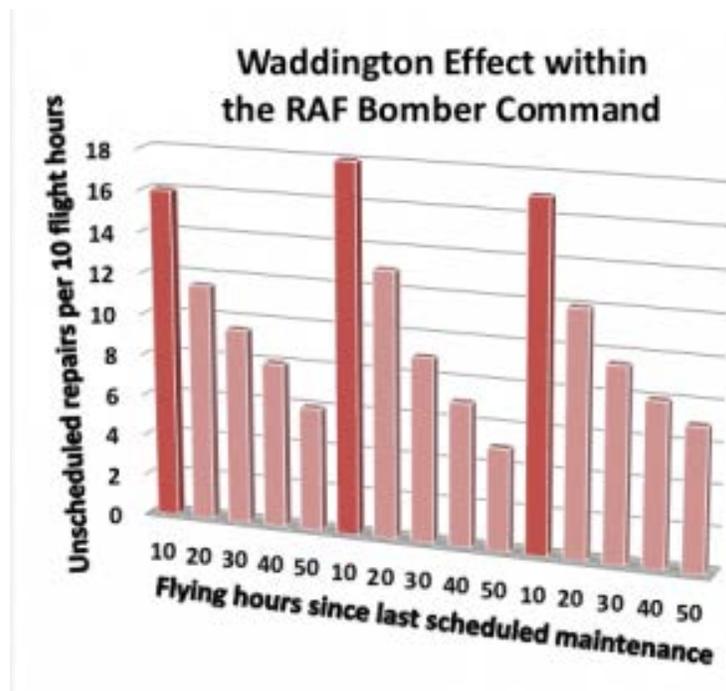
Waddington and his team started gathering data about the scheduled and unscheduled maintenance of these aircraft, and began crunching and analyzing the numbers. When he plotted the number of unscheduled aircraft repairs as a function of flight time, Waddington discovered something both unexpected and significant: The number of unscheduled repairs spiked sharply right after each aircraft underwent its regular 50-hour scheduled maintenance, and then declined steadily over time until the next scheduled 50-hour maintenance, at which time they spiked up once again.

When Waddington examined the plot of this repair data, he concluded that the scheduled maintenance (in Waddington’s own words) “tends to INCREASE breakdowns, and this can only be because it is doing positive harm by disturbing a relatively satisfactory state of affairs. There is no sign that the rate of breakdowns is starting to increase again after 40-50 flying hours when the aircraft is coming due for its next scheduled maintenance.” In other words, the observed

pattern of unscheduled repairs demonstrated that the scheduled preventive maintenance was actually doing more harm than good, and that the 50-hour preventive maintenance interval was inappropriately short.

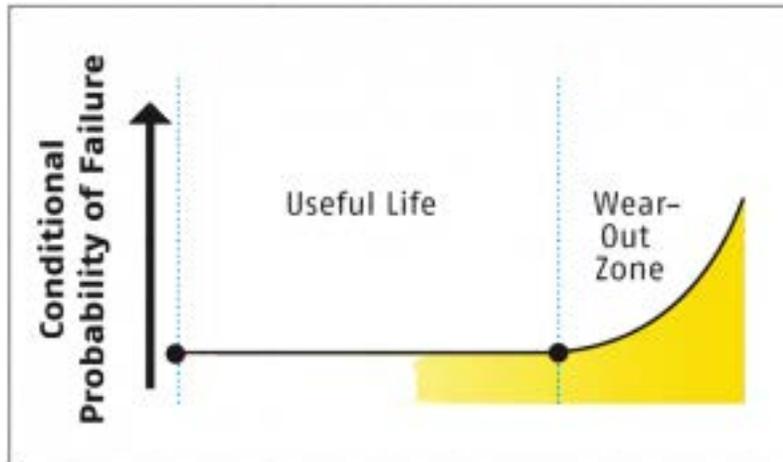
The traditional approach to PM assumes that most components start out reliable, and then at some point start becoming unreliable as they age

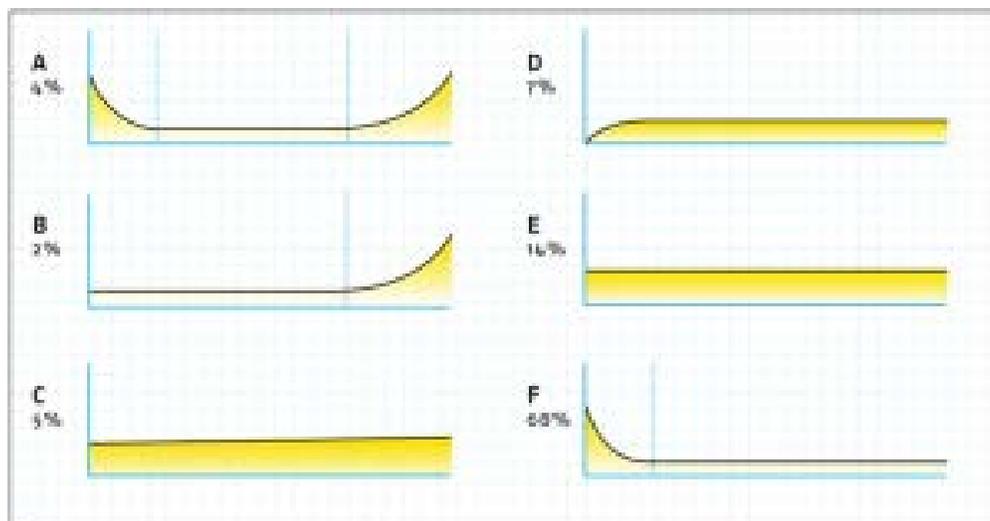
RCM researchers found that only 2% of aircraft components have failures that are predominantly age-related (curve B), and that 68% have failures that are primarily infant mortality (curve F).

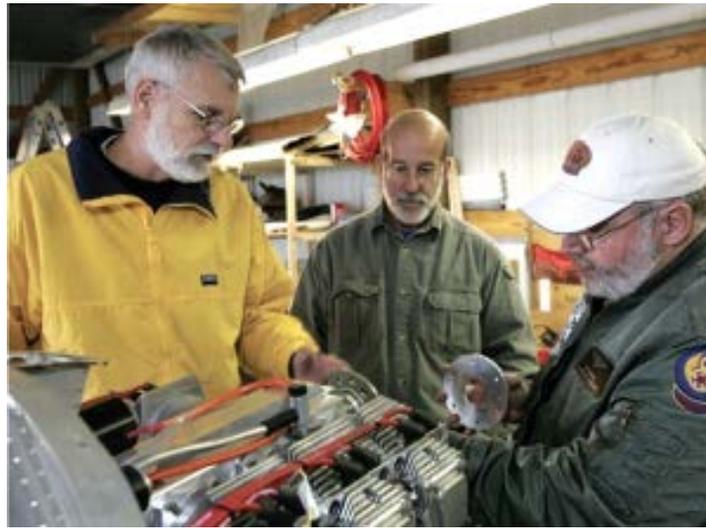
Owner-flown GA, particularly piston GA, is the only remaining segment of aviation that does things the bad old-fashioned way.

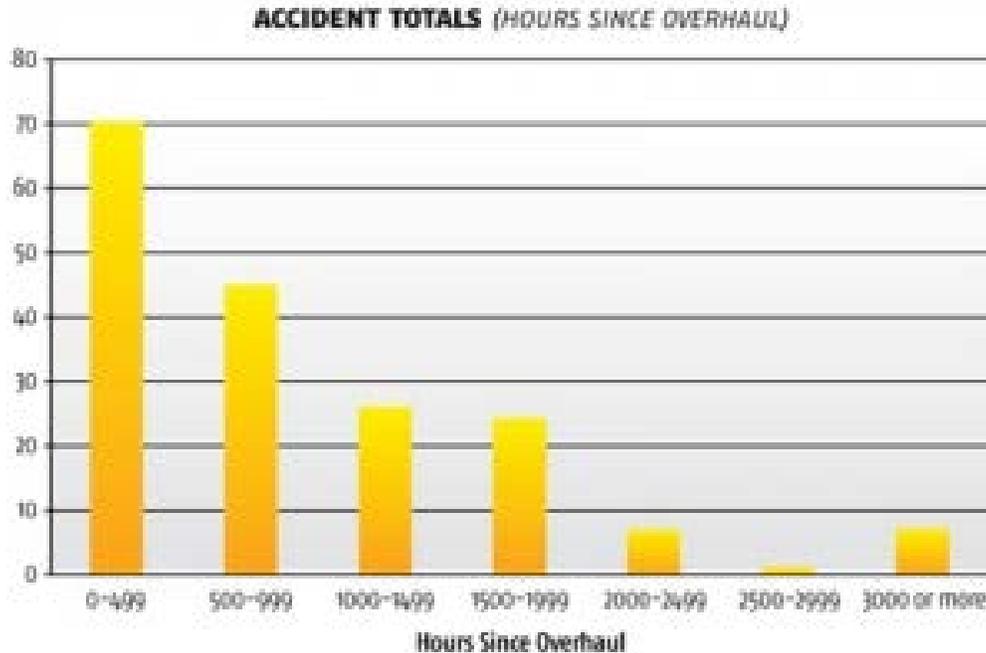
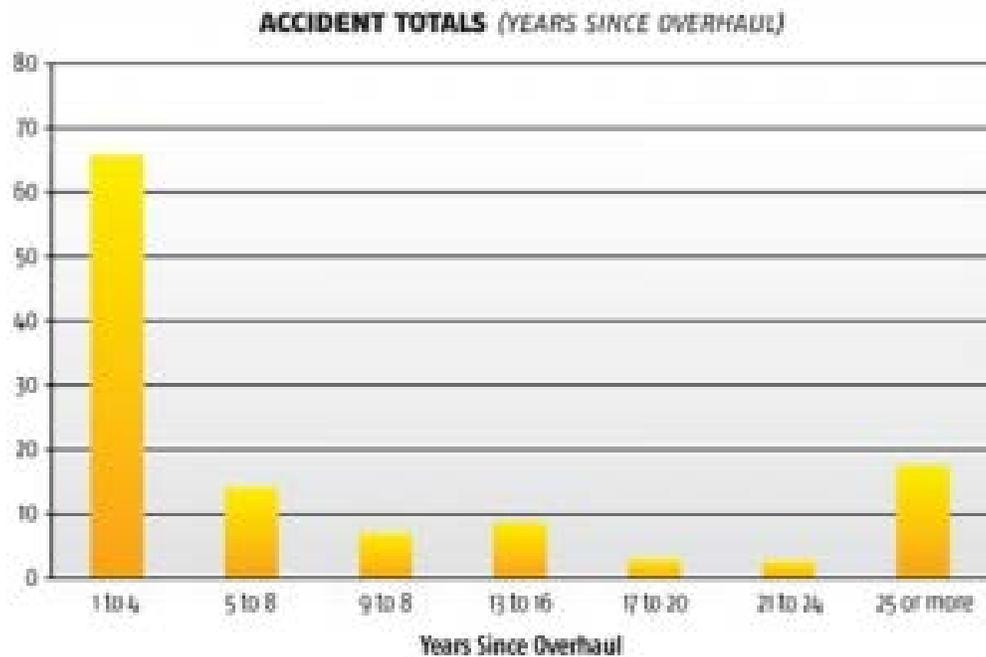
Dr. Ulrich analyzed five years' worth of NTSB accident data for the period 2001-2005 inclusive, examining all accidents involving small piston-powered airplanes (under 12,500 lbs. gross weight) for which the NTSB identified "engine failure" as either the probable cause or a contributing factor. From this population of accidents, Dr. Ulrich eliminated those involving air-race and agricultural-application aircraft. Then he analyzed the relationship between the frequency of engine-failure accidents and the number of hours on the engine since it was last built, rebuilt or overhauled. He did a similar analysis based on the calendar age of the engine since it was last built, rebuilt or overhauled. The following histograms show the results of his study:

If these histograms have a vaguely familiar look, it might be because they look an awful lot like the histograms generated by British scientist C.H. Waddington in 1943.

Now, we have to be careful about how we interpret Dr. Ulrich's findings. Ulrich would be the first to agree that NTSB accident data can't tell us much about the risk of engine failures beyond TBO, simply because most piston aircraft engines are voluntarily euthanized at or near TBO. So it shouldn't be surprising that we don't see very many engine failure accidents involving engines significantly past TBO, since there are so few of them flying. (The engines on my Cessna 310 are at more than 205% of TBO, but there just aren't a lot of RCM true believers like me in the piston GA community...yet.)

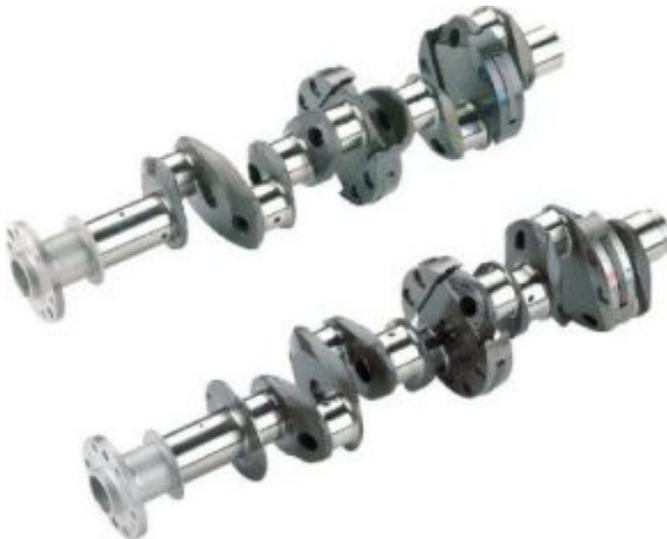
Crankshaft

There's no more serious failure mode than crankshaft failure. If it fails, the engine quits.

Yet crankshafts are rarely replaced at overhaul. Lycoming did a study that showed their crankshafts often remain in service for more than 14,000 hours (that's 7+ TBOs) and 50 years. Continental hasn't published any data on this, but their crankshafts probably have similar longevity.

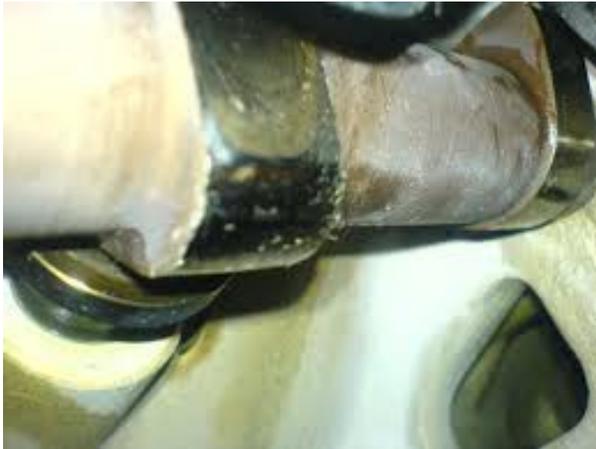
Camshaft and Lifters

The cam/lifter interface endures more pressure and friction than any other moving parts in the engine. The cam lobes and lifter faces must be hard and smooth in order to function and survive. Even tiny corrosion pits (caused by disuse or acid buildup in the oil) can lead to rapid destruction (spalling) of the surfaces and dictate the need for a premature engine teardown. Cam and lifter spalling is the number one reason that engines fail to make TBO, and it's becoming an epidemic in the owner-flown fleet where aircraft tend to fly irregularly and sit unflown for weeks at a time.

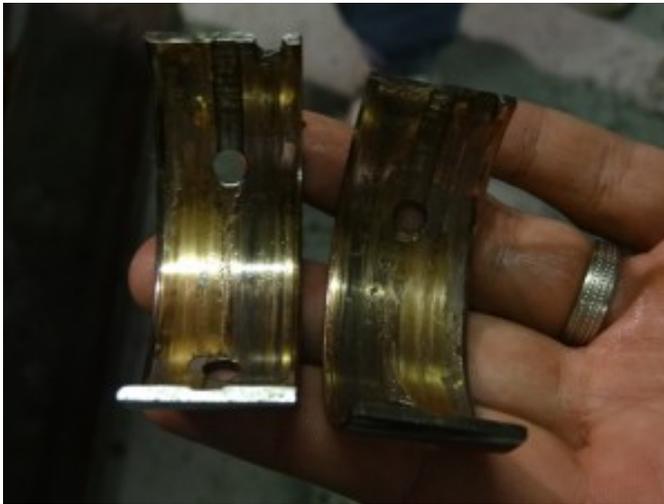
Bearings

Bearing failure is responsible for a significant number of catastrophic engine failures. Under normal circumstances, bearings have a long useful life. They are always replaced at major overhaul, but it's not unusual for bearings removed at overhaul to be in pristine condition with little detectable wear.

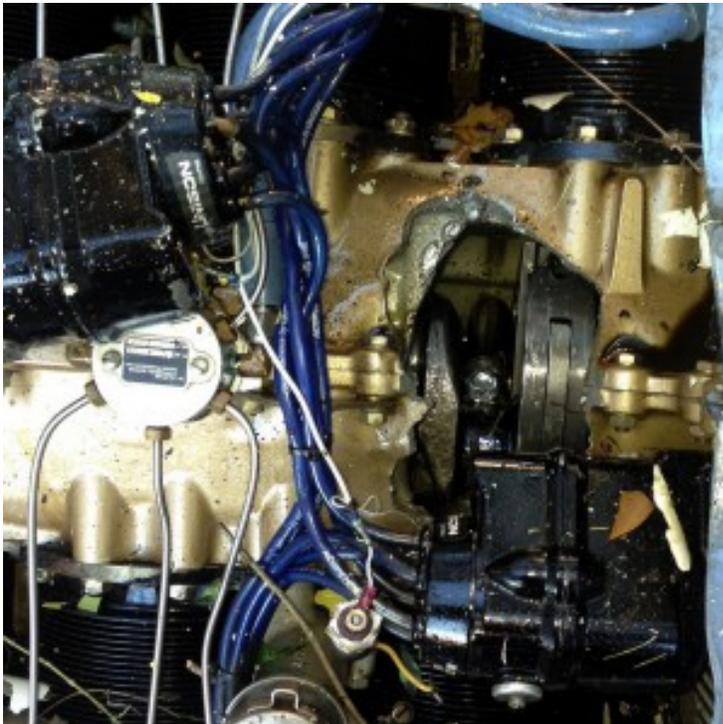
Bearings fail prematurely for three reasons: (1) they become contaminated with metal from some other failure; (2) they become oil-starved when oil pressure is lost; or (3) main bearings become oil-starved because they shift in their crankcase supports to the point where their oil supply holes become misaligned (as with the “spun bearing” pictured at right).

Spun bearings are usually infant-mortality failures that occur either shortly after an engine is overhauled (due to an assembly error) or shortly after cylinder replacement (due to lack of preload on the through bolts). Failures occasionally occur after a long period of crankcase fretting, but such fretting is usually detectable through oil filter inspection and oil analysis). They can also occur after extreme unpreheated cold starts, but that is quite rare.

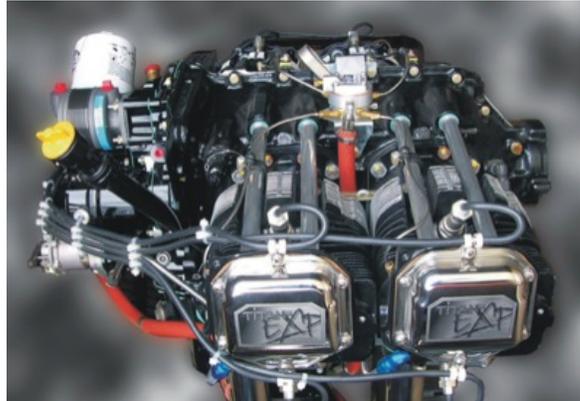
A Titan engine for experimental airplanes.

Jimmy is now working on taking ECI's Titan engine program to the next level by seeking FAA approval for these engines to be used in certificated aircraft. In theory, this ought to be relatively easy (as FAA certification efforts go) because the Titan engines are nearly identical in design to Lycoming 320 and 360 engines, and almost all the ECI-built parts are already PMA approved for use in Lycoming engines. In practice, nothing involving the FAA is as easy as it looks.

From the FAA's perspective, ECi's Titan engines are new engines, despite the fact that they are virtually clones of engines that have been flying for six decades, have a Lycoming-recommended TBO of 2,000 hours, and routinely make it to 4,000 or 5,000 hours between overhauls.

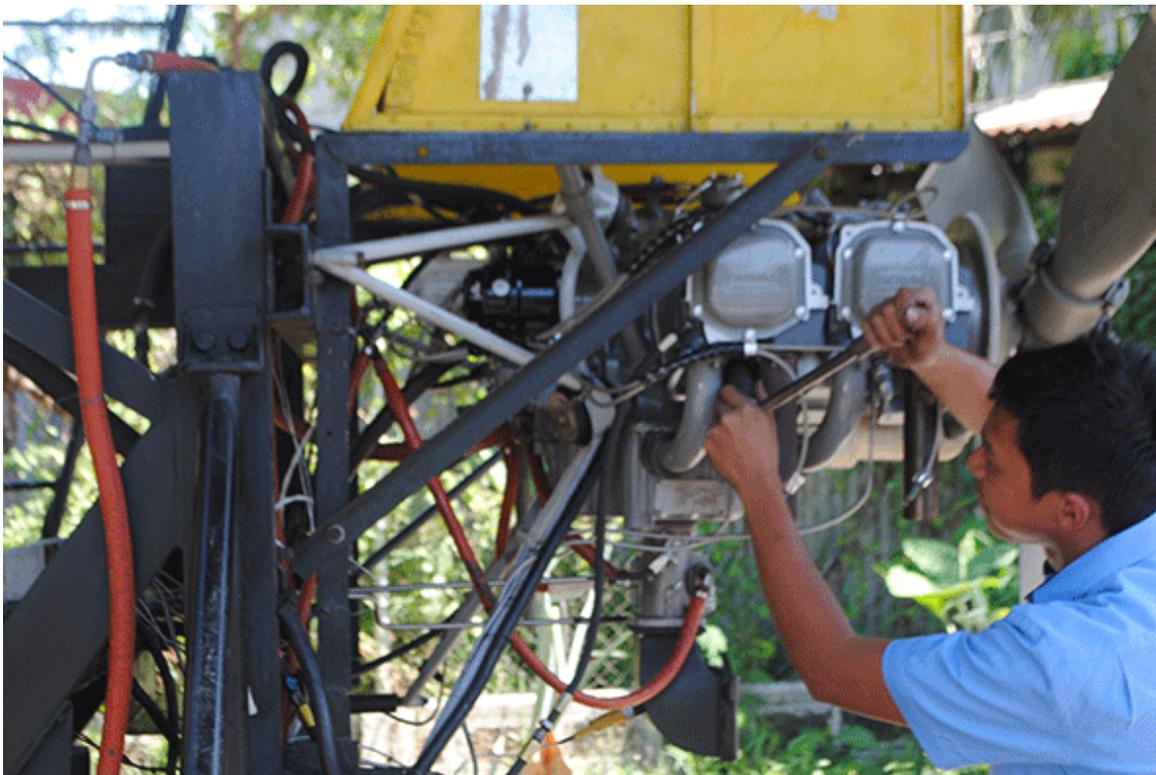
Preparing for an engine test cell endurance run.

Incidentally, there's a common misconception that engine TBOs are based on the results of endurance testing by the manufacturer. They aren't. The regulations that govern certification of engines (FAR Part 33) require only that a new engine design be endurance tested for 150 hours in order to earn certification. Granted, the 150-hour endurance test is fairly brutal: About two-thirds of the 150 hours involves operating the engine at full takeoff power with CHT and oil

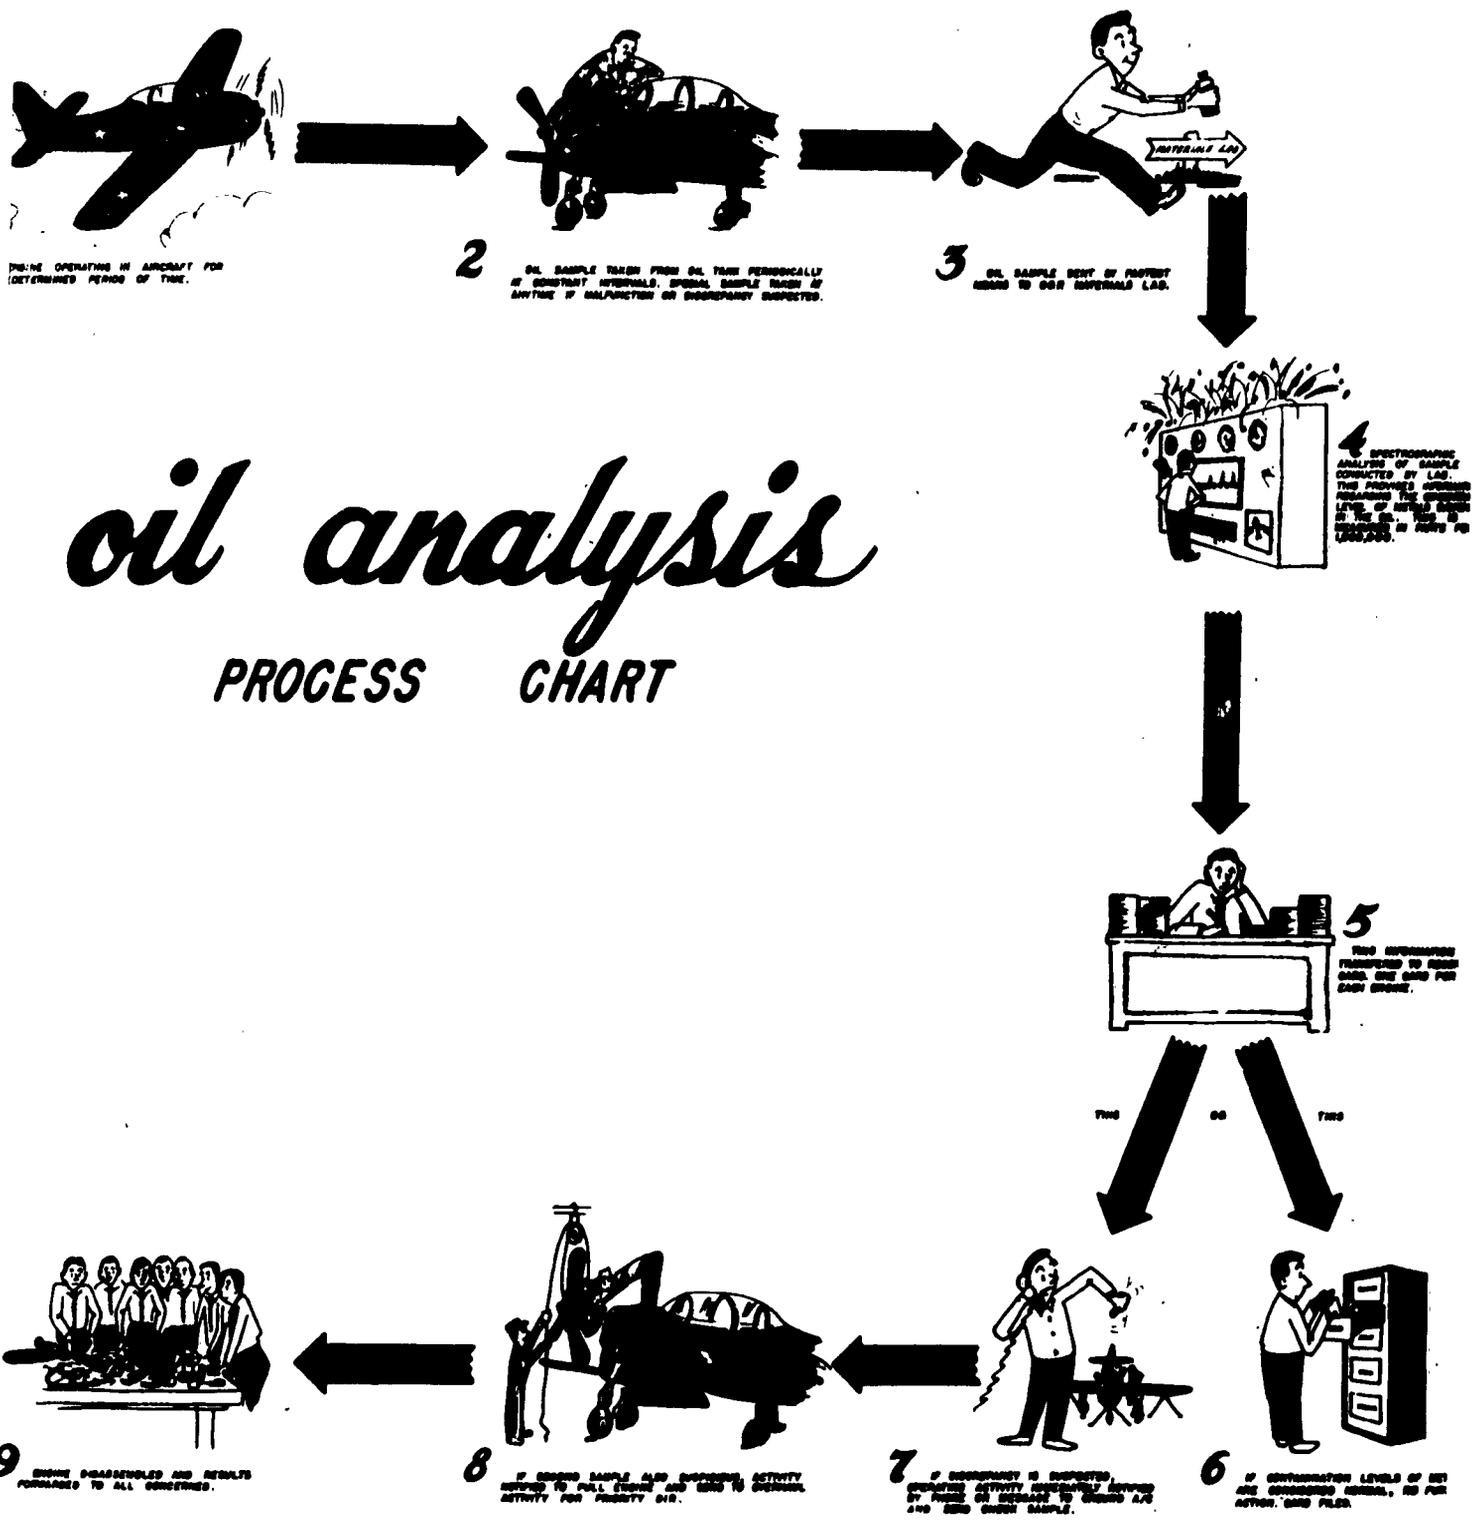
oil analysis

PROCESS CHART

In this slide, you can see that oil analysis does not stand alone. It does fill a major gap in our knowledge by giving us a technically valid insight into the condition of the vital dynamic parts in the oil wetted portion of the engine.

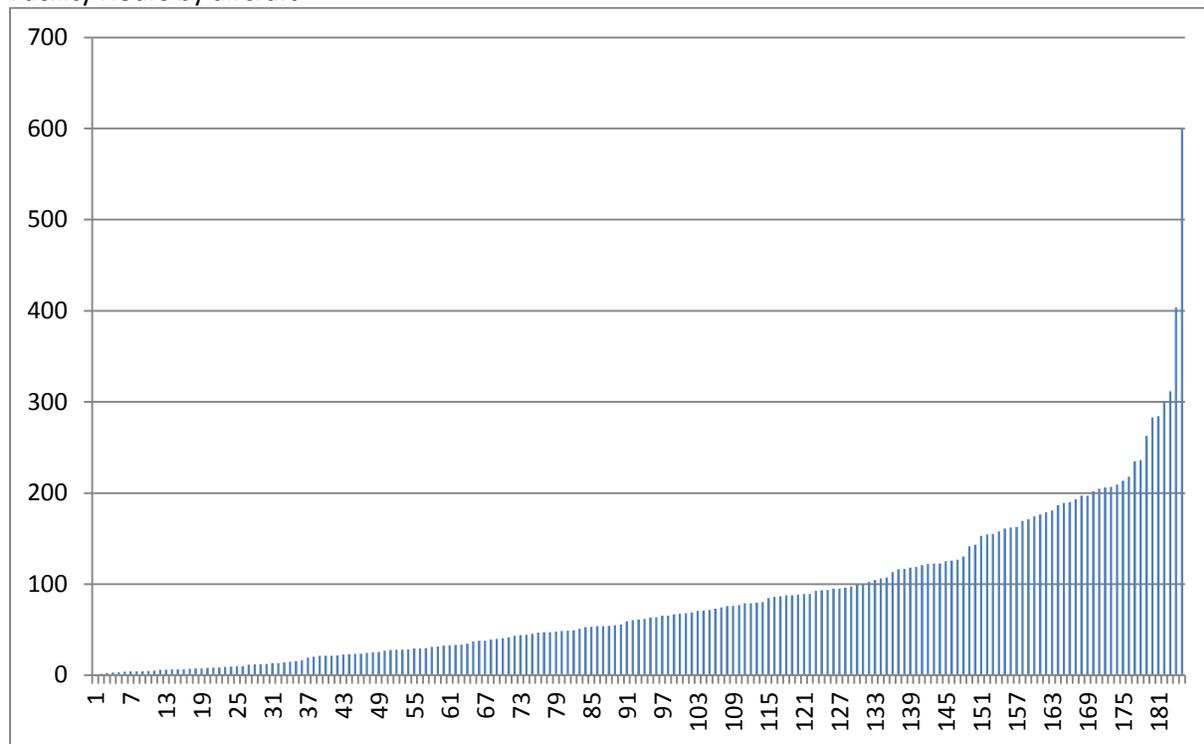
Fac Flight Hours	Aircraft	% of fleet
1-100	131	71%
100-125	13	7%
125 +	41	22%

Facility Hours by aircraft
